DMX Terminators

model: TERM, T2 technical data sheet

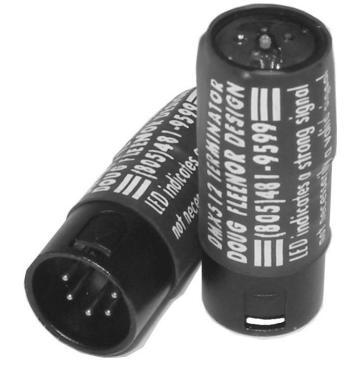
The DMX Terminator plugs into the feed-through connector of the final DMX device on a control cable. Using the DMX Terminator improves signal reliability by preventing reflections and reducing ringing. The DMX Terminator features a "happy" LED that illuminates when a strong DMX512 signal is present. The Terminator also incorporates three *Tranzorb* transient absorbing diodes to suppress spikes that can appear on the control cable during electrical storms. Radio frequency interference (RFI) is bypassed to chassis ground via the .001uF capacitance of the *Tranzorb* diode. An economy version (T2) is also available that does not have the indicator, transient absorbers, or RFI suppression.

Connector:	3 pin or 5 pin male XLR, gold plated contacts
Indicator:	Low current red light emitting diode (LED) illuminates on signal strength of 2 volts or greater.
Indicator circuit:	2K series resistor limits the LED's effect on termination performance. 1N4004 diode across LED protects against reverse voltage.
Termination resistance:	120 ohms +/- 10% between pins 2 & 3
Termination power capacity:	2 watts
Transient absorbing capacity:	500 watts
Transient clamp time:	Less than 5nS (0.00000005 seconds)
Transient clamp voltage:	Approximately 7 volts
Transient absorber locations:	Pins 2 and 3 clamped to pin 1. Pin 1 clamped to shell.
Capacitance:	Between pins 1 & 2: .001 uF Between pins 1 & 3: .001 uF Between pin 1 and shell: .001 uF
Size and weight:	1.9" long, 0.8" maximum diameter, 1 ounce
SPECIFICATIONS: models: T2-3, T	2-4 & T2-5
Connector:	3 pin, 4 pin or 5 pin male XLR, gold plated contacts
Termination resistance:	120 ohms +/- 10% between pins 2 & 3
